# A STUDY OF THE STEPS REQUIRED TO PROVIDE FOR CURRENT AND FUTURE NEEDS OF THE PEEKSKILL FIRE DEPARTMENT BY RENOVATING AND ADDING ONTO THE CURRENT FACILITIES

**A Study of the Steps Required  
to Provide for Current and Future Needs  
of the Peekskill Fire Department  
by Renovating and Adding onto the Current Facilities**

**March 23, 2010**

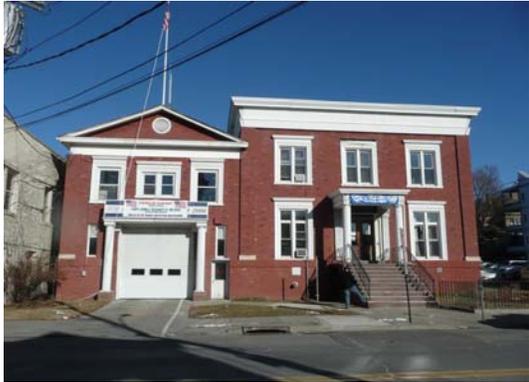
<ul style="list-style-type: none"><li>• Exterior skin is imitation brick with limited lifespan</li><li>• Rain water dumps off roof into alley</li></ul>

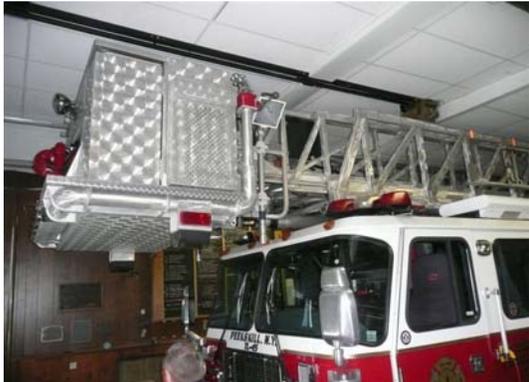
<ul style="list-style-type: none"><li>• Inadequate head room prevents use of 100% source capture fume exhaust</li></ul>

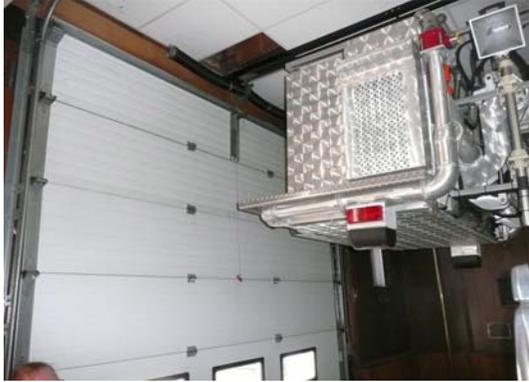
<ul style="list-style-type: none"><li>• Inadequate space</li></ul>

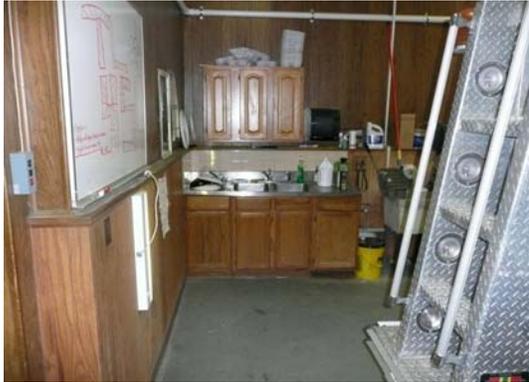
<ul style="list-style-type: none"><li>• Inadequate space</li><li>• Bunker's kitchen is in apparatus bay</li></ul>

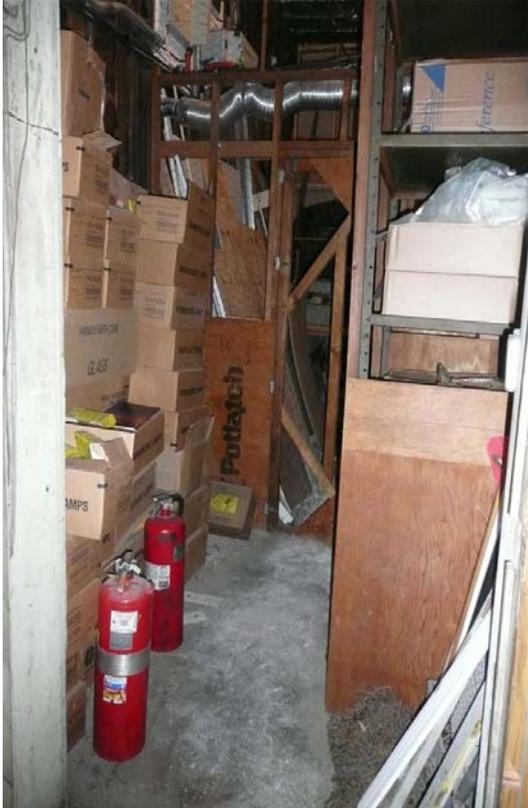
<ul style="list-style-type: none"><li>• Inadequate storage</li><li>• No fire protection</li></ul>

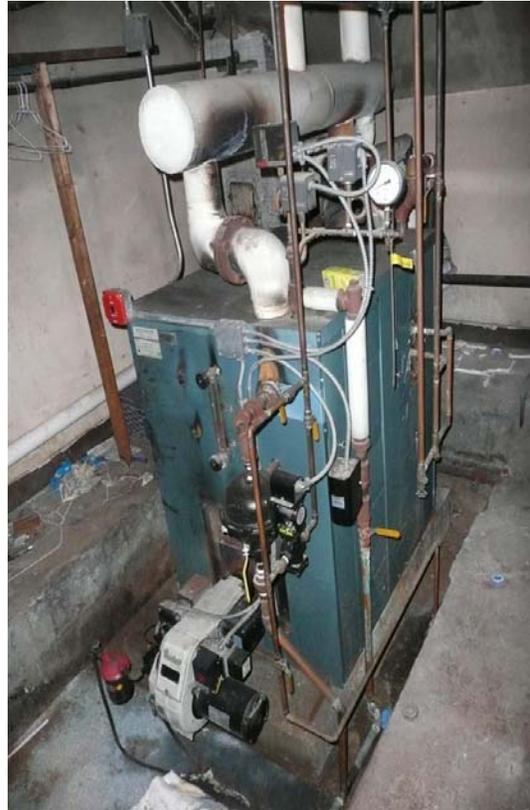
- Mechanical systems are antiquated

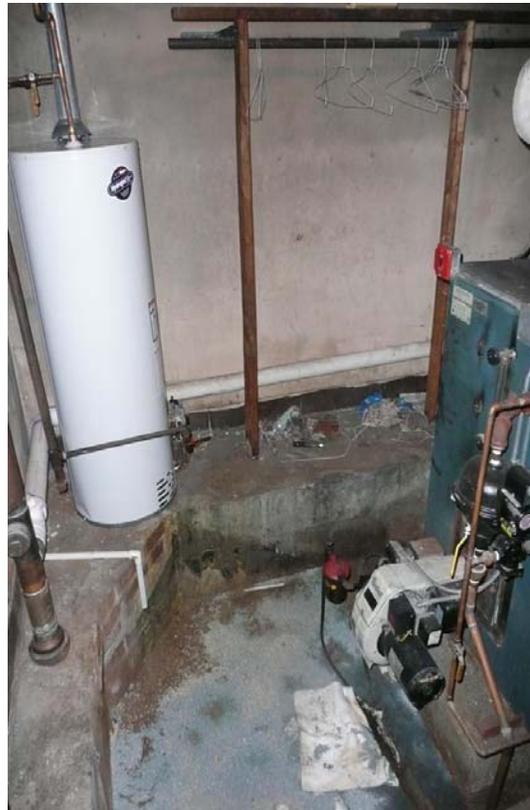
- Mechanical systems are antiquated

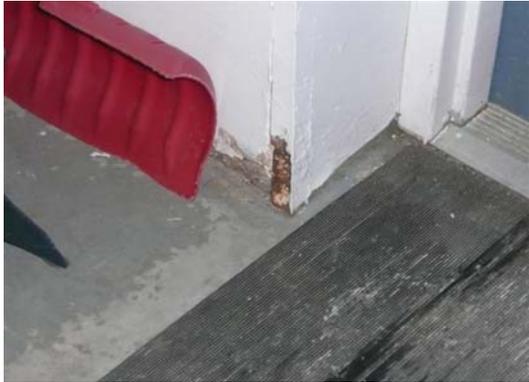
<ul style="list-style-type: none"><li>• Corrosion</li></ul>

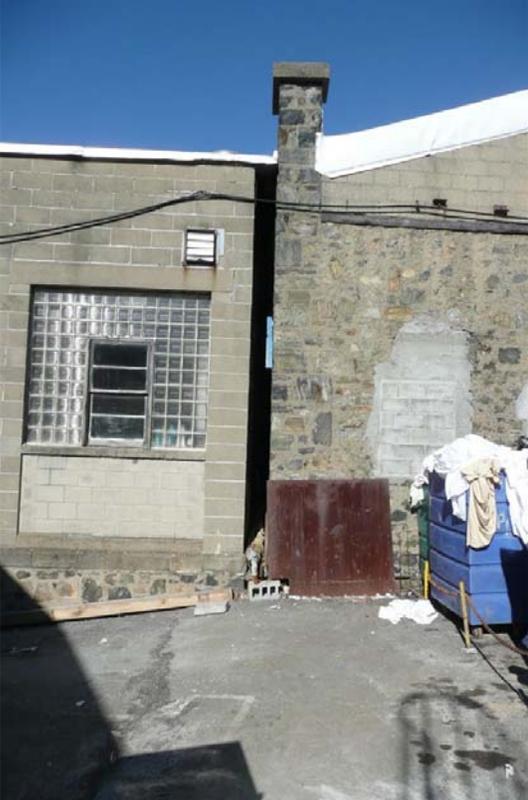
<ul style="list-style-type: none"><li>• Building envelope is dilapidated</li></ul>

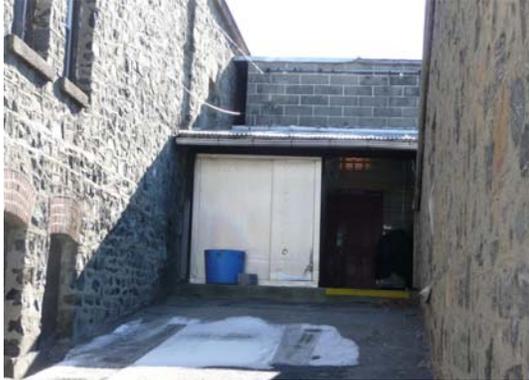
<ul style="list-style-type: none"><li>• Secondary egress from 2nd floor is through alley</li></ul>

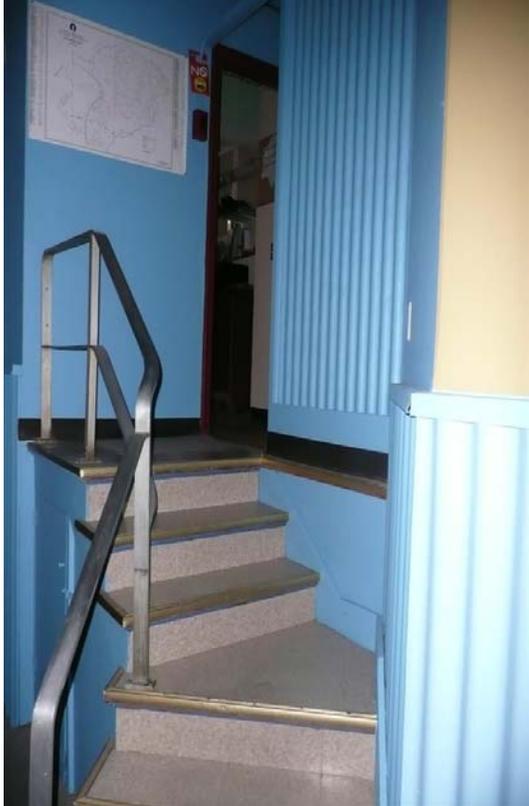
<ul style="list-style-type: none"><li>• Stair to bunk room &amp; bathroom does not comply with ANSI standards</li></ul>

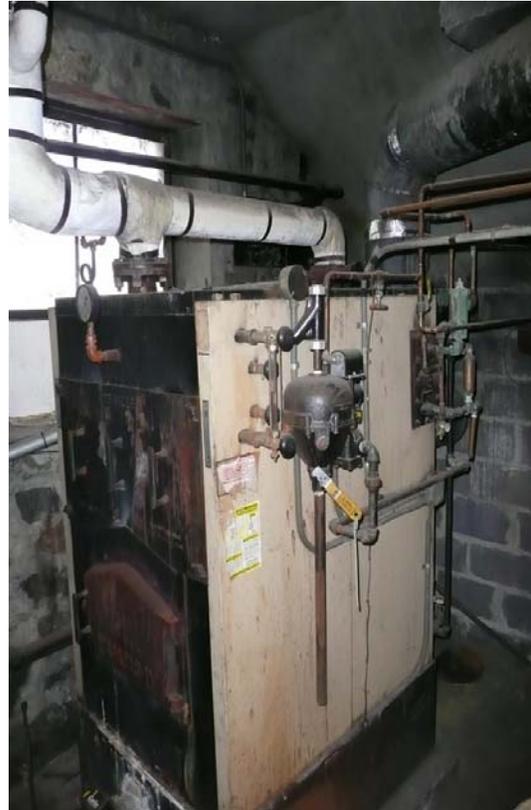
- Boiler room is cramped
- Equipment is archaic
- 2nd floor grossly overheats

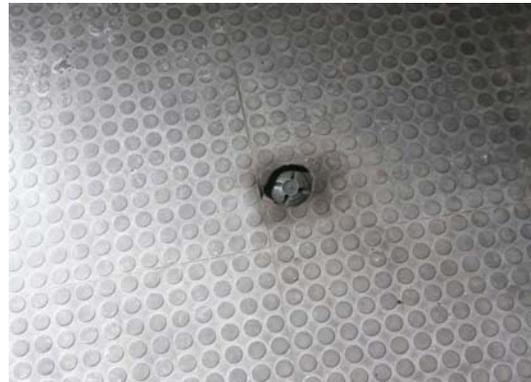
- Fuel oil fill in stairwell is a gross life safety violation

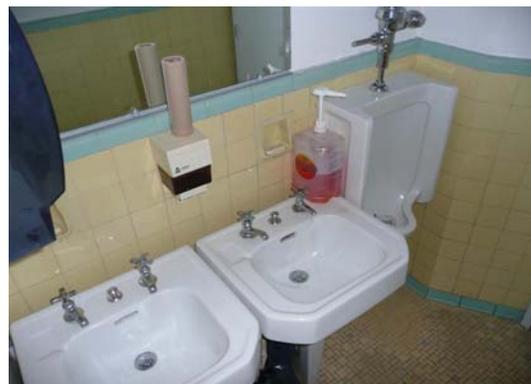
- Bathrooms do not comply with ANSI or ADA

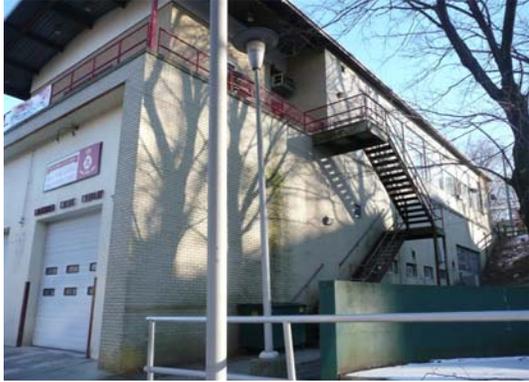
<ul style="list-style-type: none"><li>• 2nd floor secondary egress is via an exposed fire escape</li><li>• Stucco applied over windows on upper porch</li></ul>

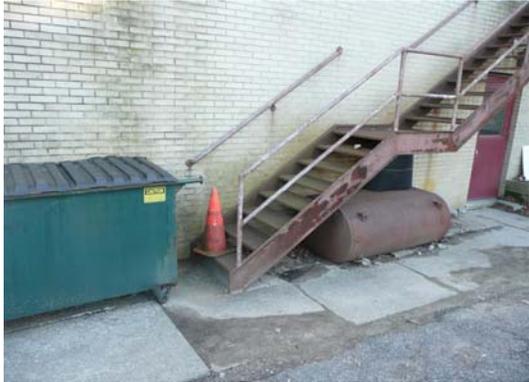
<ul style="list-style-type: none"><li>• Lack of on-site storage results in blockage of 2nd floor secondary egress</li></ul>

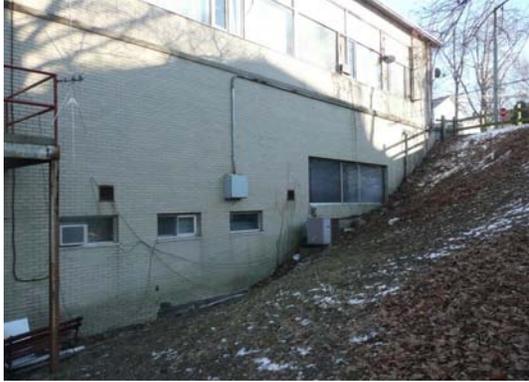
<ul style="list-style-type: none"><li>• Roof water collects at base of wall</li><li>• Site drainage traps water against building</li></ul>

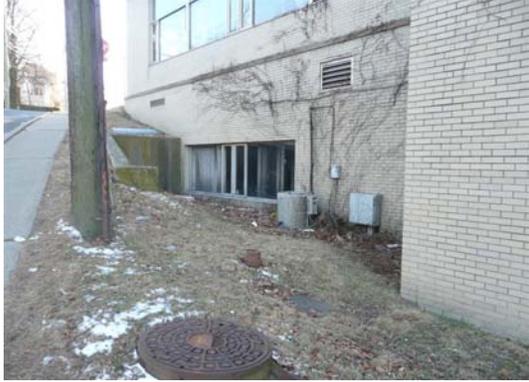
<ul style="list-style-type: none"><li>• Roof water collects at base of wall</li><li>• Site drainage traps water against building</li></ul>

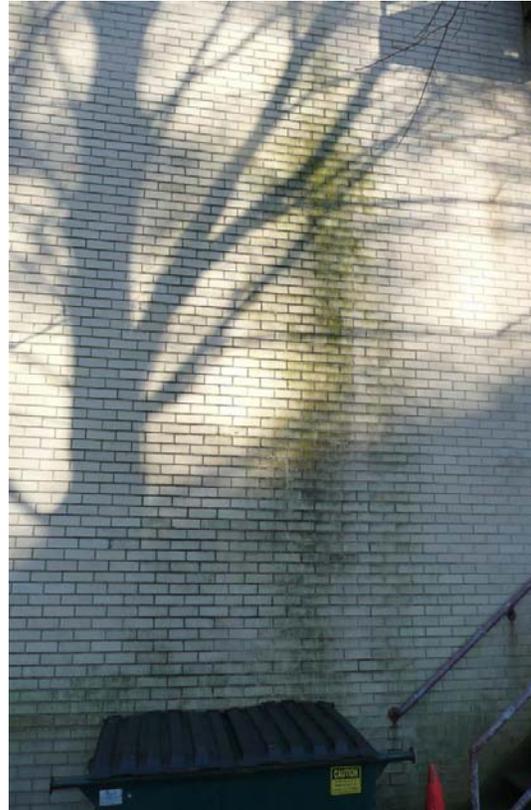
- Water and mold deterioration

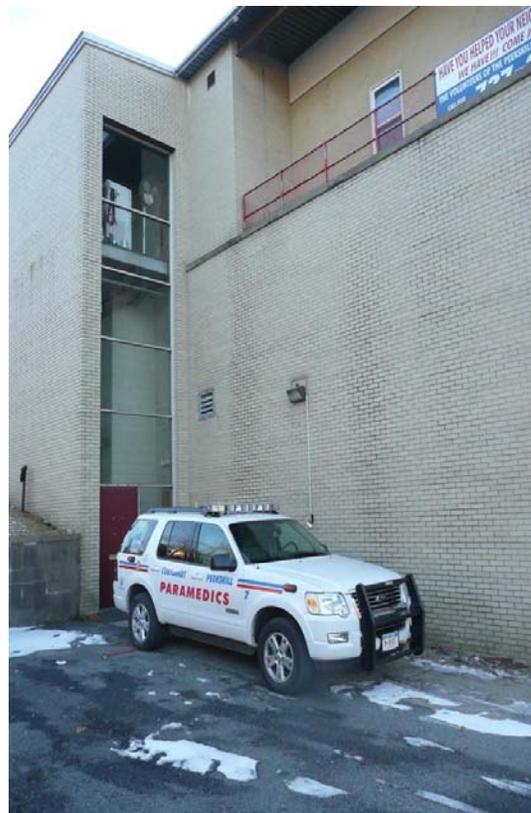
- On-site parking limited to one space which blocks door egress access

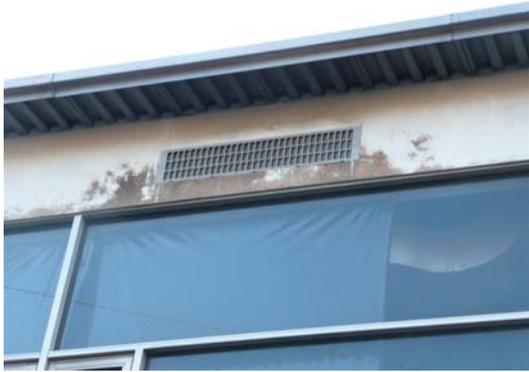
<ul style="list-style-type: none"><li>• Moisture deterioration</li></ul>

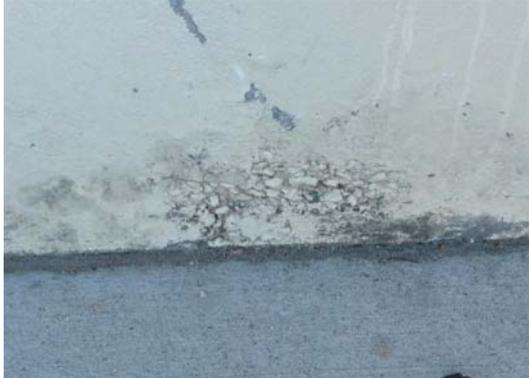
<ul style="list-style-type: none"><li>• Moisture deterioration</li></ul>

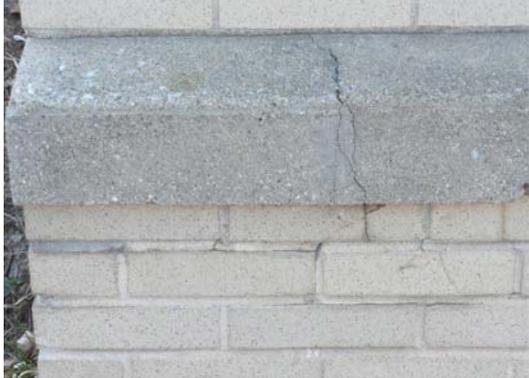
<ul style="list-style-type: none"><li>• Exterior masonry cracks</li></ul>

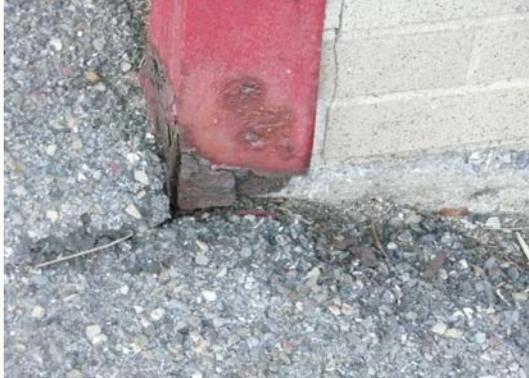
<ul style="list-style-type: none"><li>• Corrosion at door guards</li></ul>

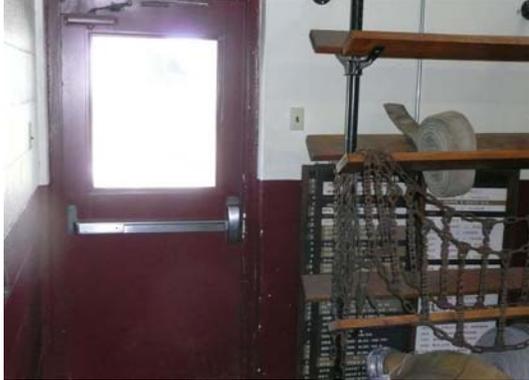
<ul style="list-style-type: none"><li>• Inadequate storage space results in hose rack obstructing ANSI clearance at exit</li></ul>

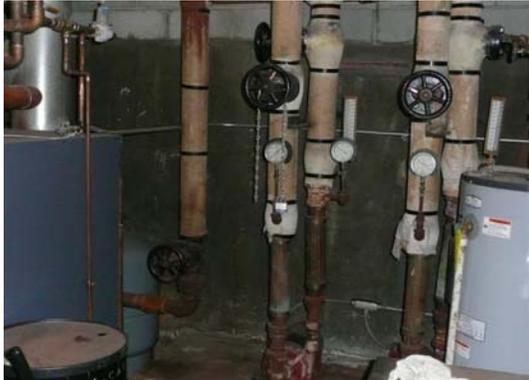
<ul style="list-style-type: none"><li>• Lack of storage area results in storage in mechanical room, a code violation</li></ul>

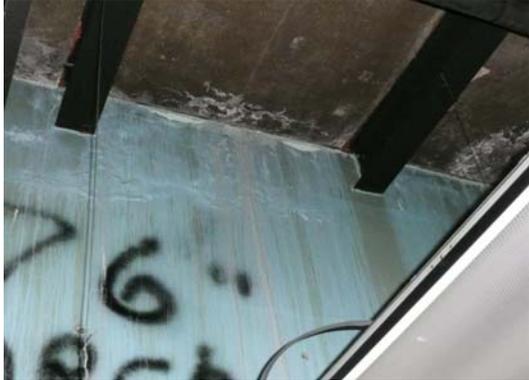
<ul style="list-style-type: none"><li>• Water leakage from upper bay prevents washing of vehicles and causes corrosion</li></ul>

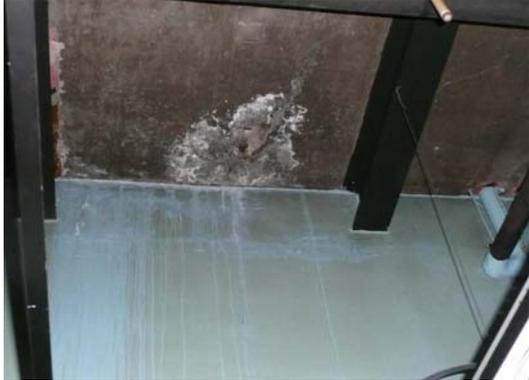
<ul style="list-style-type: none"><li>• Water leakage from upper bay prevents washing of vehicles and causes corrosion</li></ul>

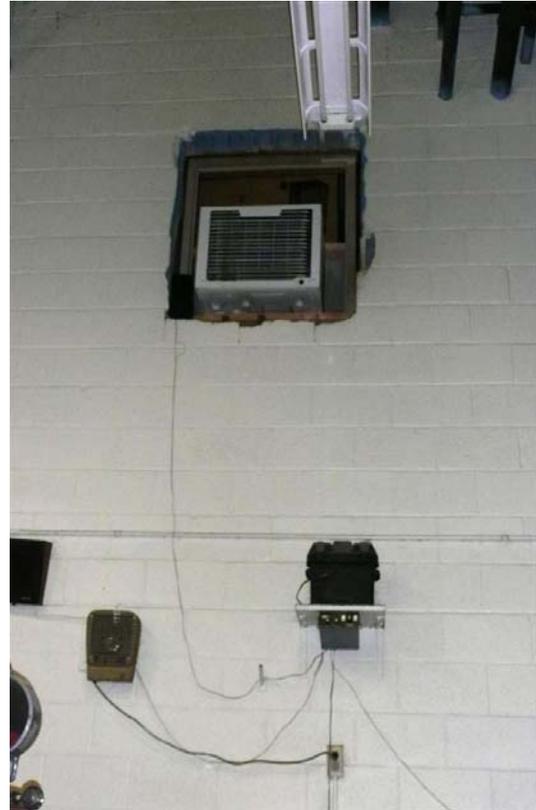
- Lack of operable A/C results in cooling members' room by discharging hot air into apparatus bay

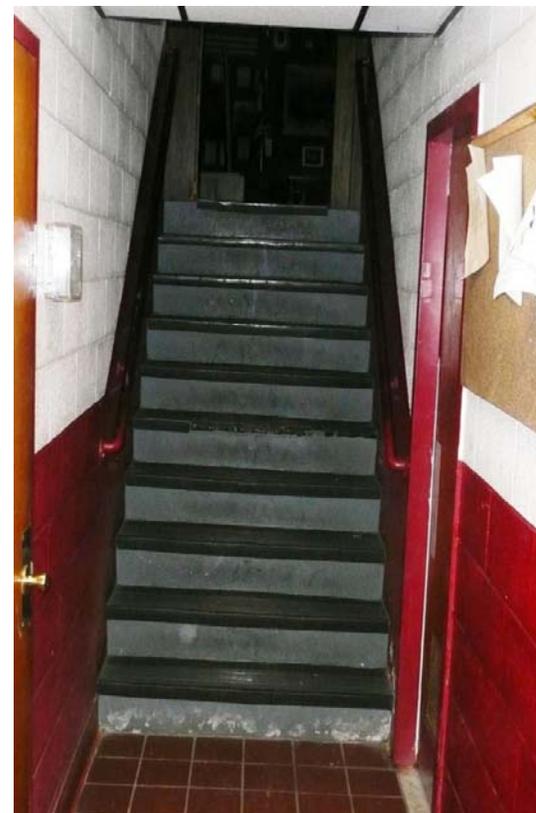
- Stairs not ANSI compliant

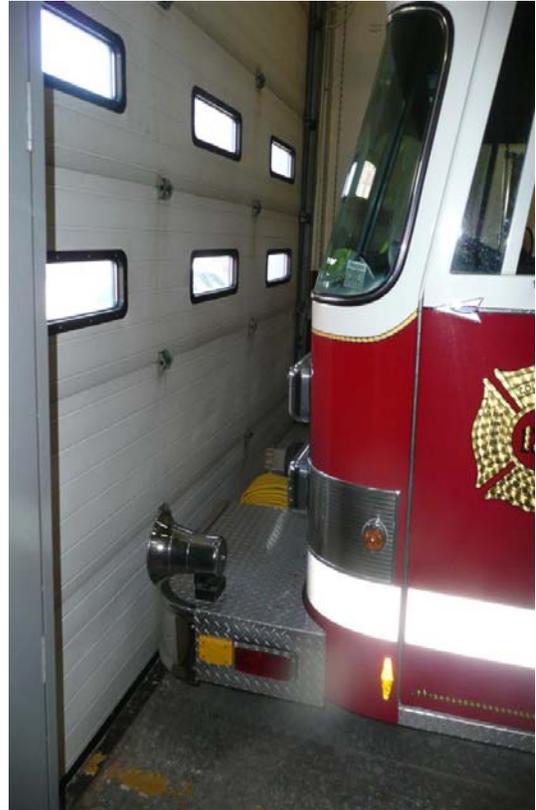
- Inadequate clearance

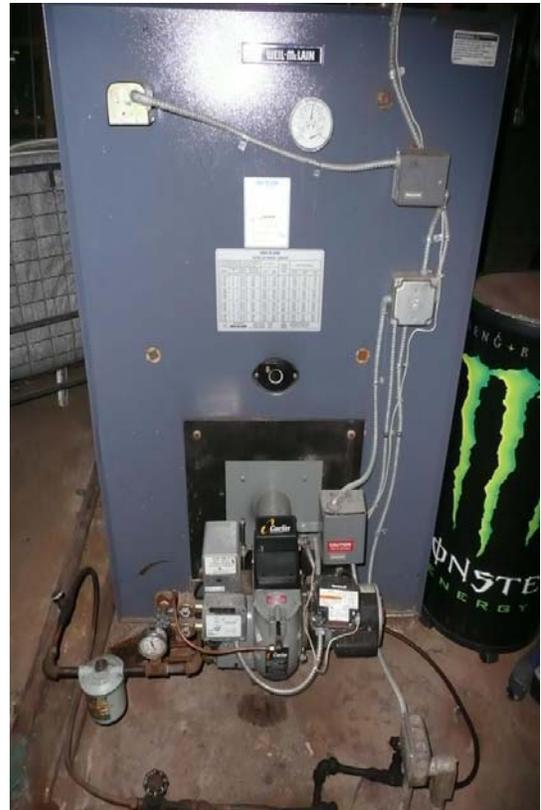
- Lack of storage area results in storage in mechanical room, a code violation

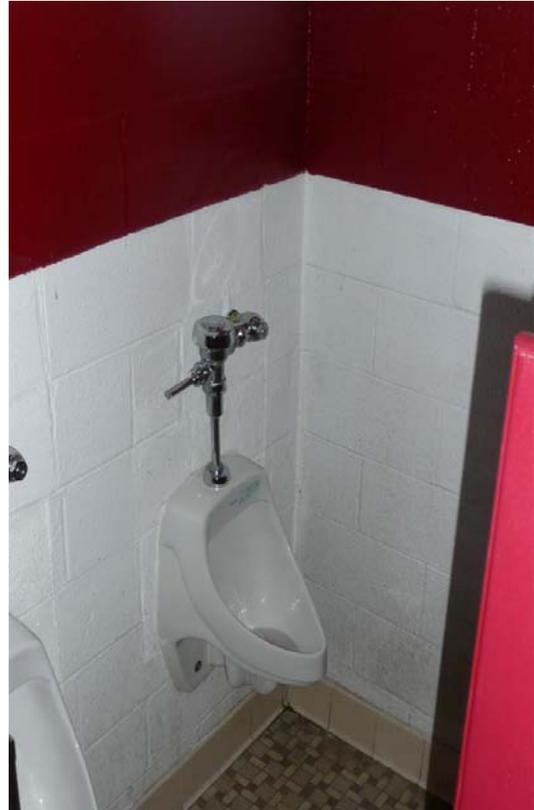
- Bathrooms do not comply with ANSI or ADA standards

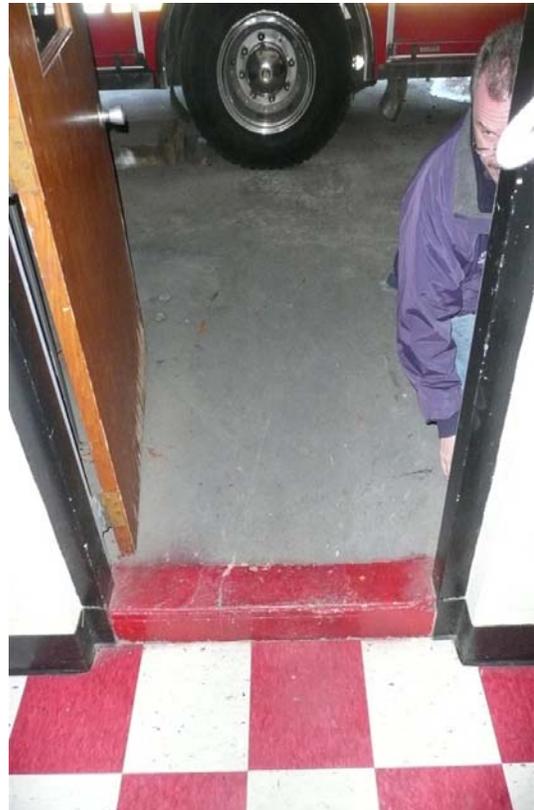
- Change in elevation to apparatus bay does not comply with ANSI or ADA standards
- Apparatus bay slab elevation above hallway elevation introduces risk in the event of fuel tank rupture

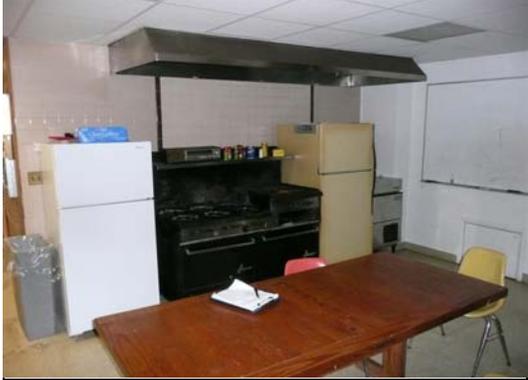
<ul style="list-style-type: none"><li>• Non-compliant kitchen hood</li></ul>

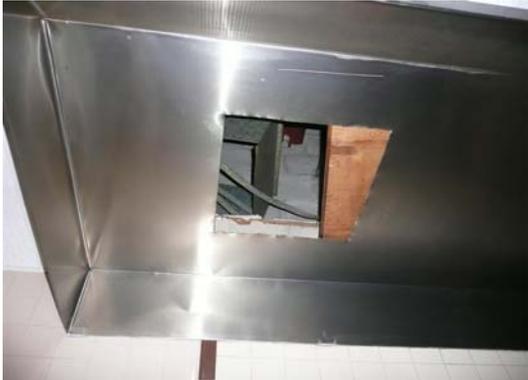
<ul style="list-style-type: none"><li>• Fire hazard</li></ul>

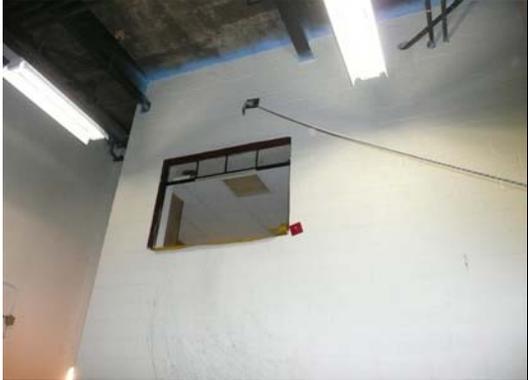
<ul style="list-style-type: none"><li>• Unprotected opening from kitchen/dining to apparatus bay</li></ul>

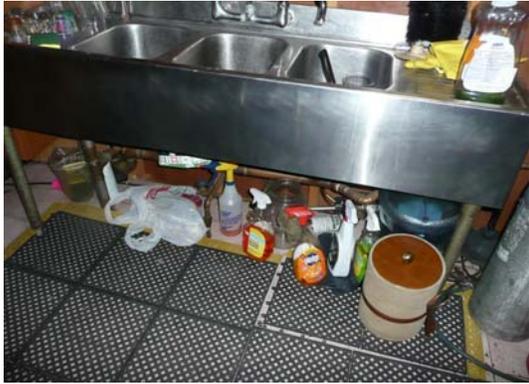
<ul style="list-style-type: none"><li>• Plumbing system leaks</li><li>• Inadequate storage</li></ul>

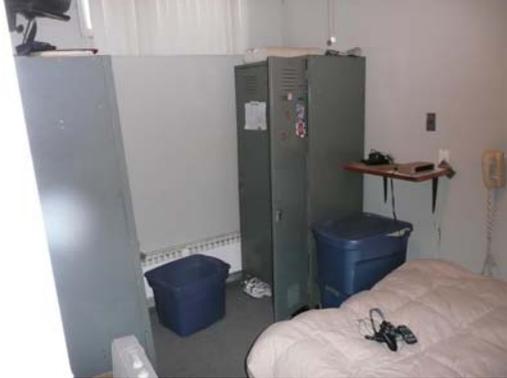
<ul style="list-style-type: none"><li>• Inadequate bunk room</li></ul>

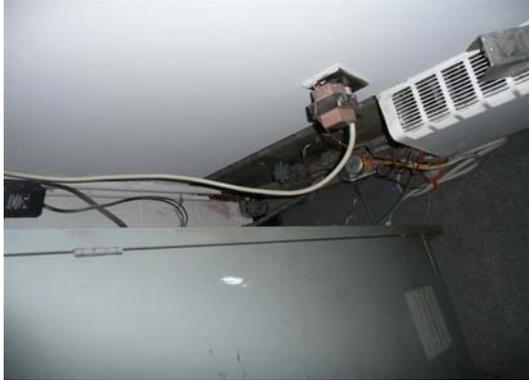
<ul style="list-style-type: none"><li>• Mechanical equipment in bunk room</li></ul>

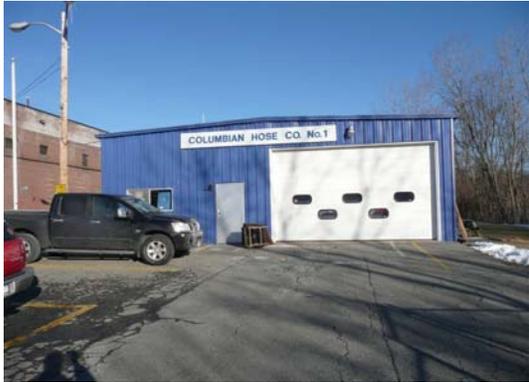
<ul style="list-style-type: none"><li>• Exterior skin is in poor condition</li><li>• Pavement is too thin and deteriorated</li></ul>

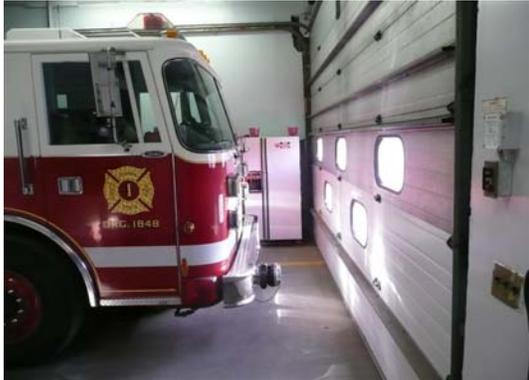
<ul style="list-style-type: none"><li>• Inadequate front clearance</li></ul>

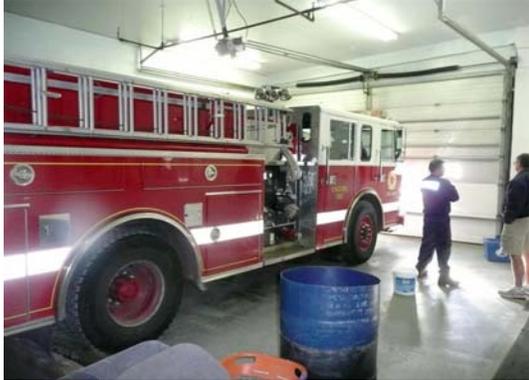
<ul style="list-style-type: none"><li>• No source capture fume exhaust</li><li>• No general exhaust</li></ul>

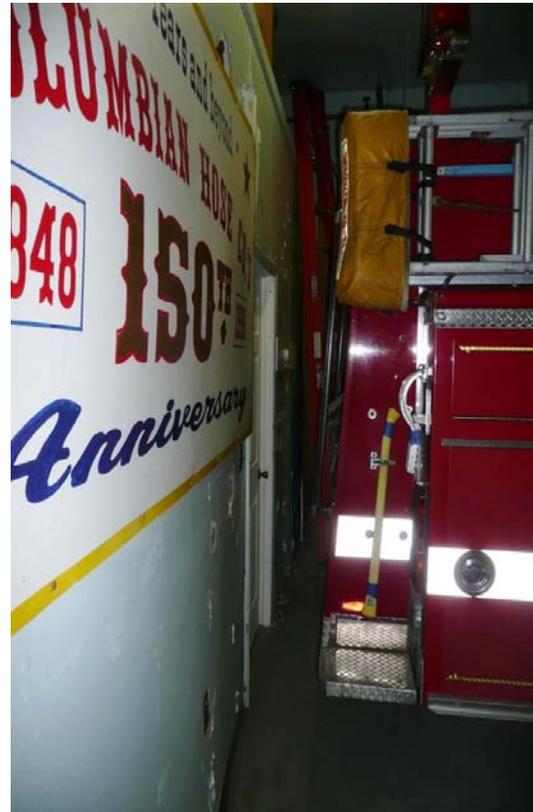
- Inadequate rear clearance

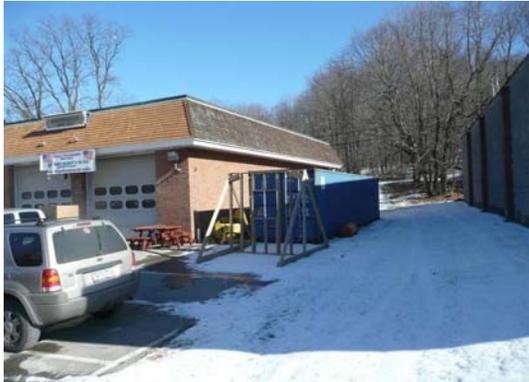
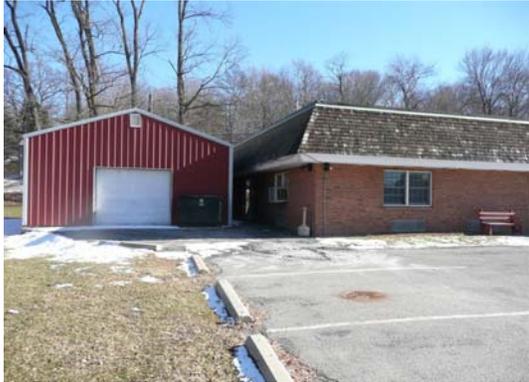
<ul style="list-style-type: none"><li>• Inadequate storage results in materials stored on site</li></ul>

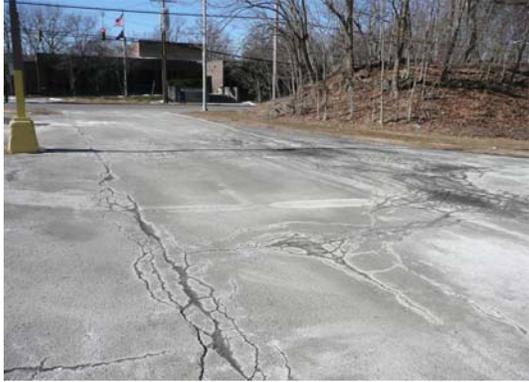
<ul style="list-style-type: none"><li>• All pavement is in failure</li></ul>

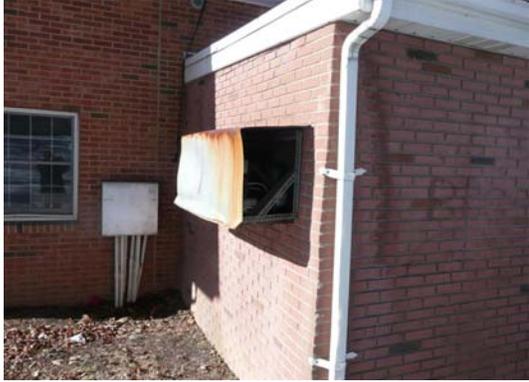
<ul style="list-style-type: none"><li>• Mechanical system is deteriorated</li></ul>

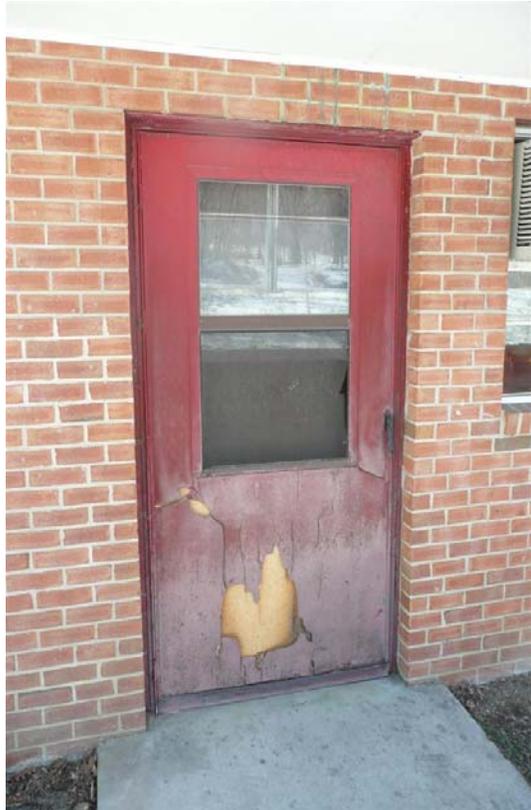
- Door needs replacement

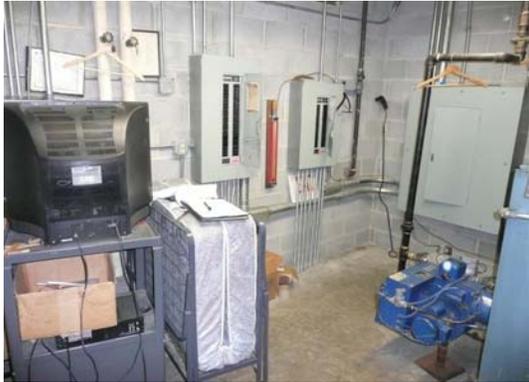
<ul style="list-style-type: none"><li>• Lack of storage results in code violation of storage in mechanical room</li></ul>

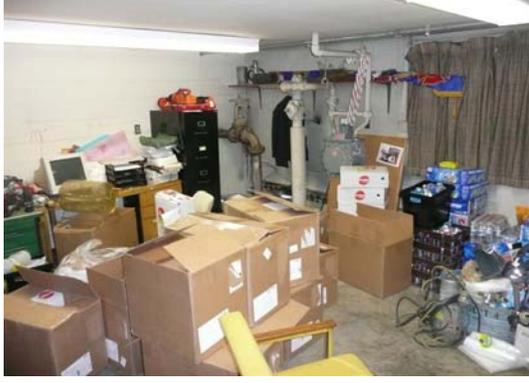
<ul style="list-style-type: none"><li>• Lack of adequate storage area</li></ul>

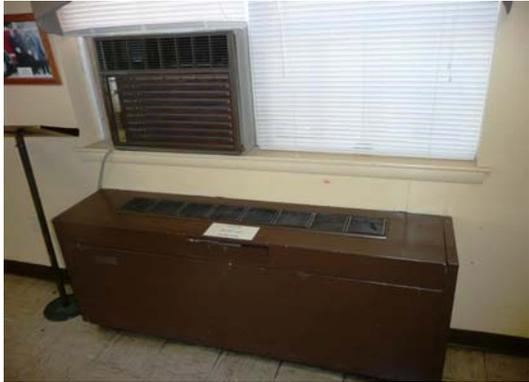
<ul style="list-style-type: none"><li>• Defunct HVAC system: A/C only available by (#) thru-wall units</li></ul>

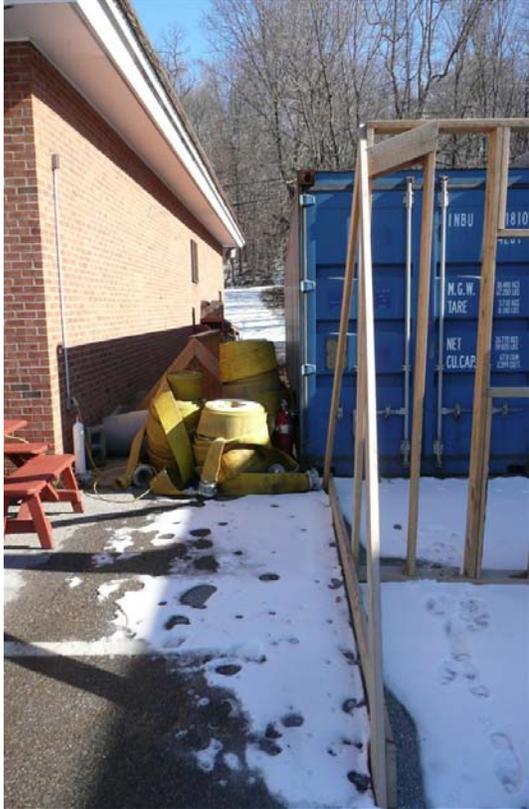
<ul style="list-style-type: none"><li>• Inadequate storage area</li></ul>
