# Design Guidelines

## Downtown Peekskill Historic District

**City of Peekskill  
Historic and Landmarks Preservation Board**

**2002**

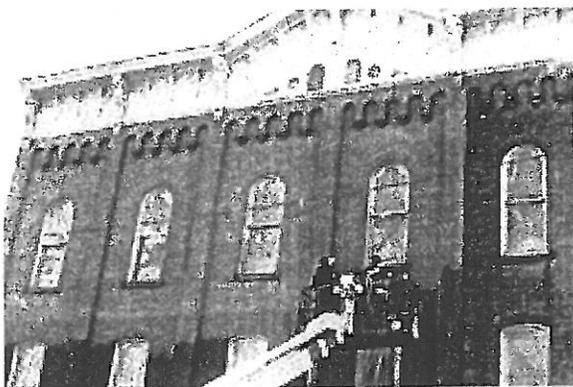
Fig. 2 The cleaning of this previously-unpainted 1880s building demonstrates the dramatic visual effect of properly executed masonry cleaning. Using an environmentally-acceptable cleaning solution and a low-pressure water rinse, the surfaces were cleaned without any repointing being necessary.

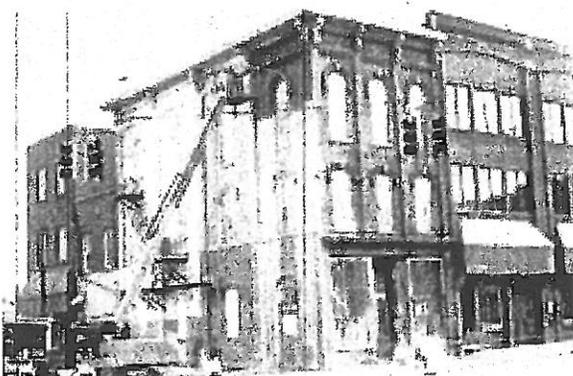
Fig. 3 The process of cleaning a painted historic building involves both the stripping of paint and cleaning of dirt which has accumulated on the surface.

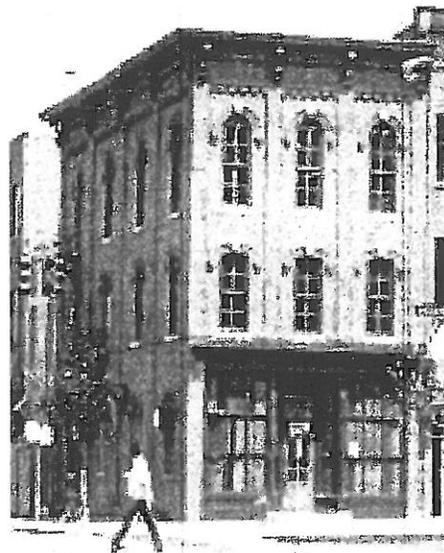
Fig. 4 When paint is stripped from a historic building, not only must care be taken not to harm the brick and mortar, but the residue must be collected and disposed of in an environmentally-responsible manner (see Fig. 3, left). As shown in the "after" view, above, the results are impressive.

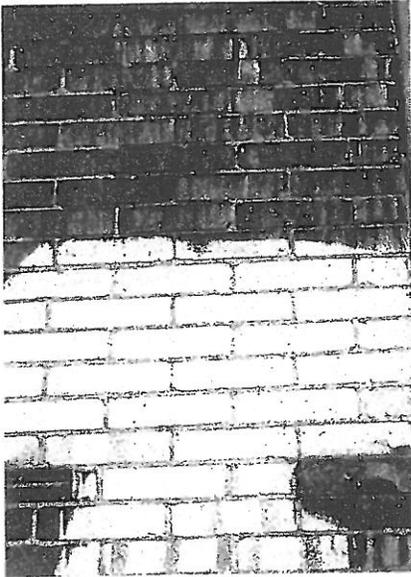
Fig. 5 A test patch taken prior to a cleaning project will confirm whether or not a building is a candidate for such rehabilitation activity.

1.4 A test patch should be taken prior to beginning a major cleaning project, since the masonry may not be suitable for cleaning due to its age or condition, or the presence of replacement materials that are better masked with paint. Always inspect the building fully before beginning a cleaning project; window and door openings may have been altered and in-filled with brick that does not match the original and the building may look better re-painted than cleaned.

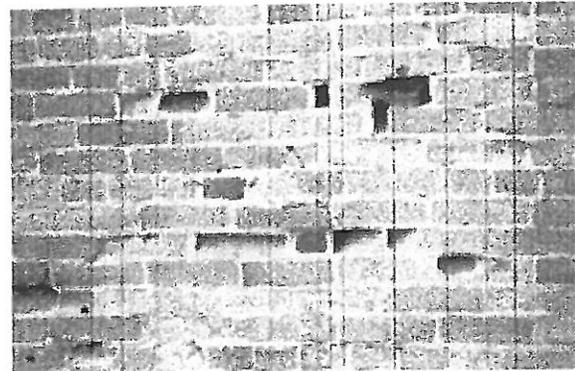
Fig. 6 When abrasive cleaning is undertaken, including treatments such as sandblasting or high-pressure water washing, spalling can occur to the soft brick surfaces of historic brick such as that found throughout downtown Peekskill.

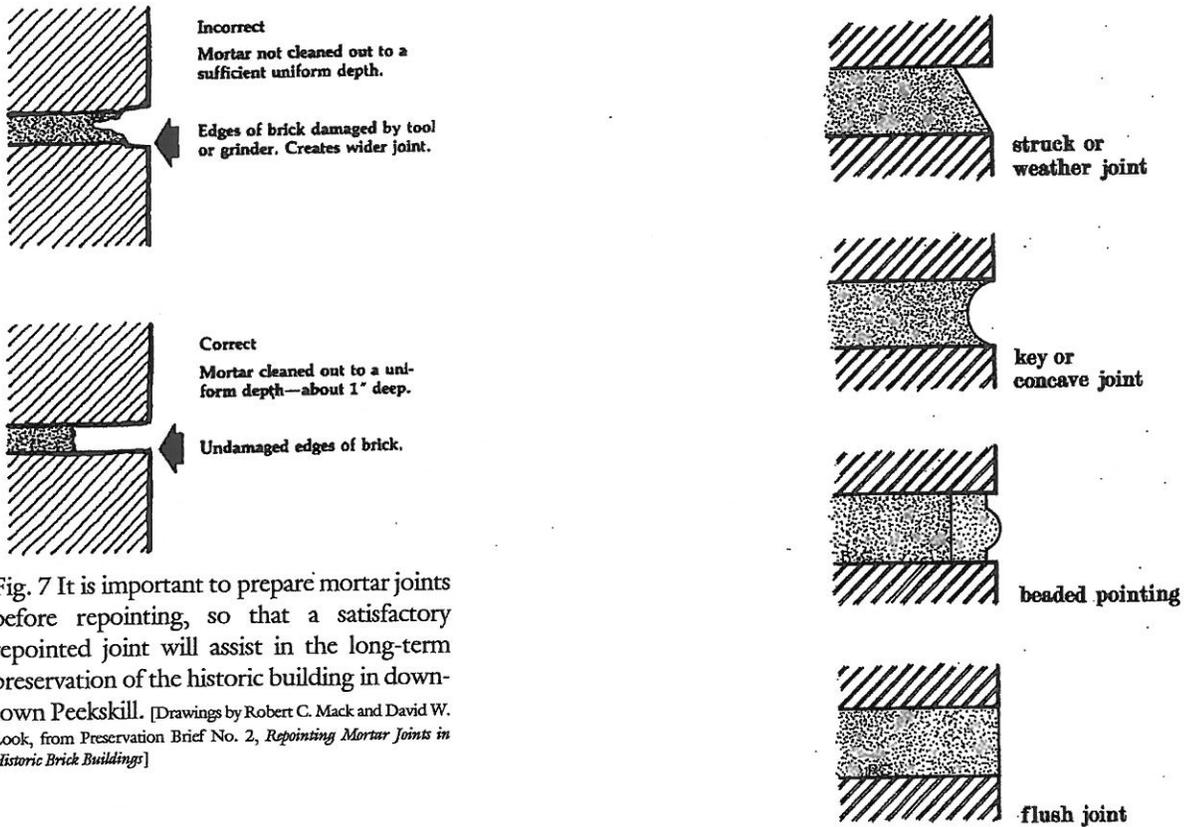
Fig. 7 It is important to prepare mortar joints before repointing, so that a satisfactory repointed joint will assist in the long-term preservation of the historic building in downtown Peekskill. [Drawings by Robert C. Mack and David W. Look, from Preservation Brief No. 2, *Repointing Mortar Joints in Historic Brick Buildings*]

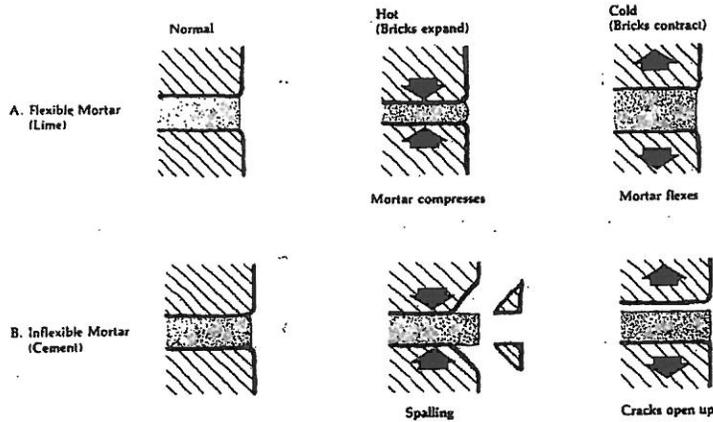
Fig. 9 The use of mortar which is significantly harder than the original can cause irreparable damage to historic bricks. This illustration shows the effect of changes in temperature upon a flexible lime mortar (top) and an inflexible high-cement mortar (bottom). As freezing and thawing occurs, the materials expand and contract; inflexible mortar will cause the bricks to fail and spall. [Drawing adapted from *Maintenance for Old Buildings*, National Swedish Institute for Building Research as reprinted in Preservation Brief No. 2, *Repointing Mortar Joints in Historic Brick Buildings*]

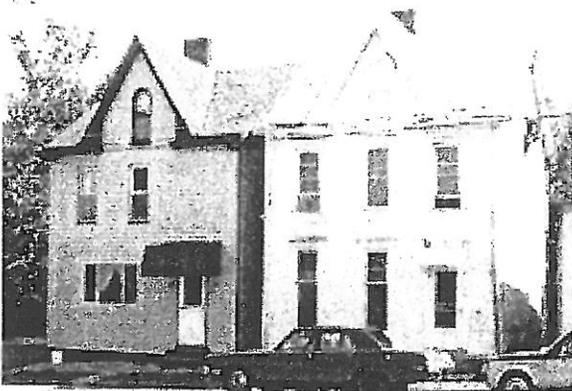
Fig. 10 As shown in the above photo of two previously-identical houses, the installation of non-historic siding results in significant damage to the historic character of the building. Such treatments should not be undertaken in downtown Peekskill.

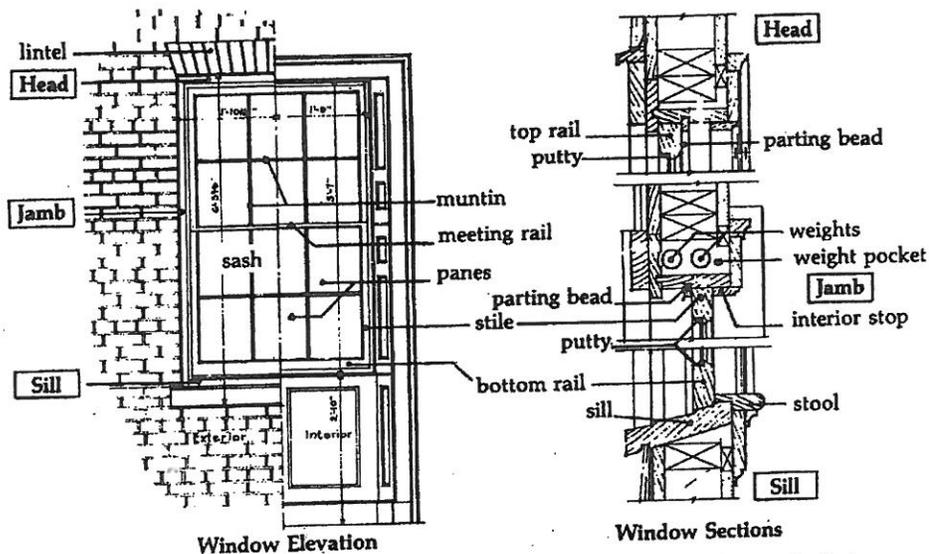
Fig. 11 The above drawings identify a variety of the elements of historic wood windows such as those found throughout downtown Peekskill. [from Preservation Brief No. 9, *The Repair of Historic Wood Windows*]

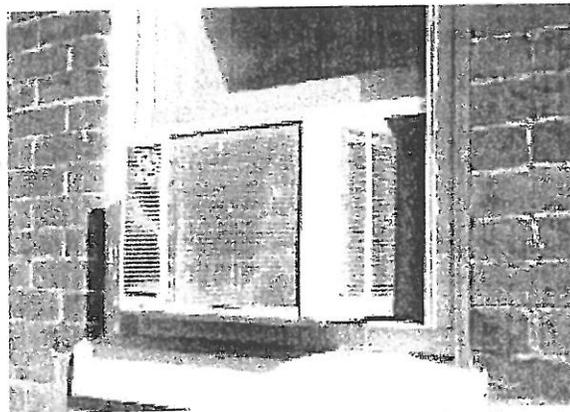
Fig. 12 Window air conditioners should be installed only on secondary elevations--preferably on the rear or side of a building--and should never damage historic building materials.

- 3.9 Avoid the placement of window air conditioners where they will be easily seen from the street; attempts should be made to insert units on secondary elevations.

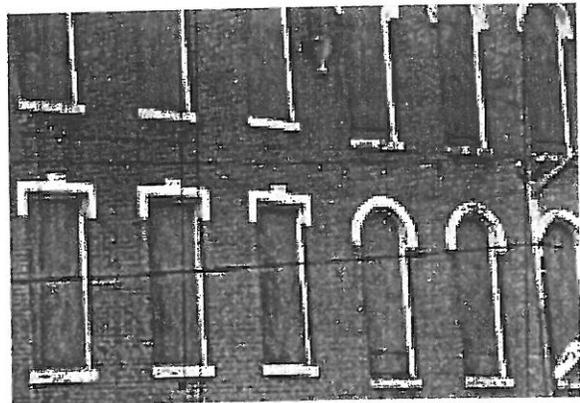
Fig. 13 Whether space is vacant or fully-utilized, windows should always be maintained in good condition, without broken panes or deteriorated trim. The boarding up of windows should not occur within the historic district.

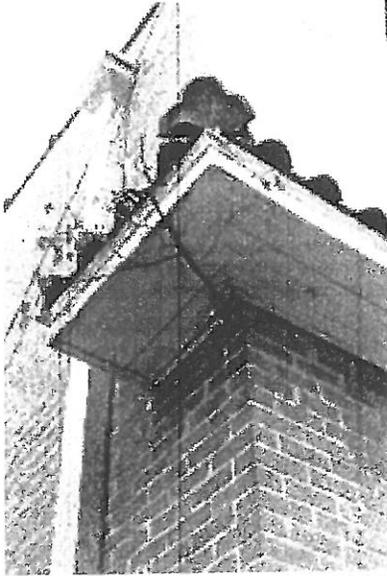
Fig. 14 If buildings and their individual components are not maintained regularly, deterioration will surely follow. In the photo above, dirt has accumulated in the gutter, encouraging the growth of unwanted and potentially damaging plant material.

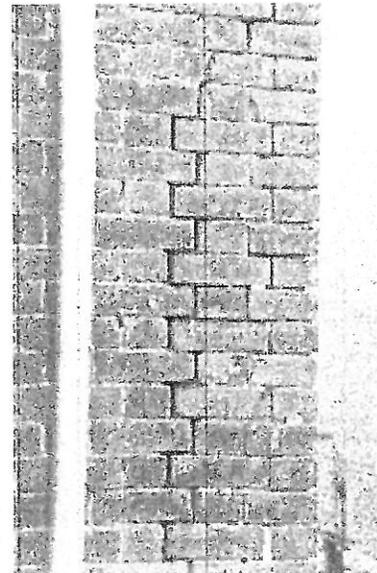
Fig. 15 The new half-round downspout shown above was installed well after the lack of proper drainage had caused failure in the corner of this historic brick building. Proper guttering and water diversion systems should be well-maintained throughout the historic district.

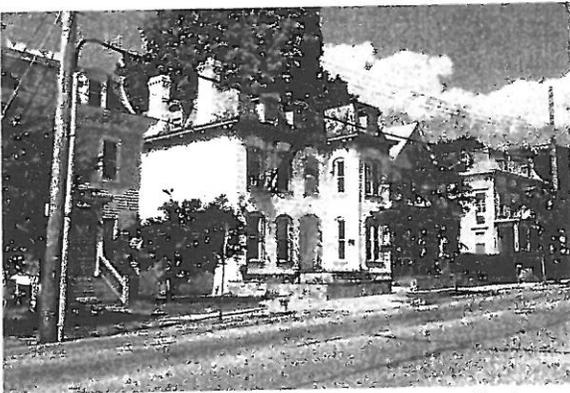
Fig. 17 Most porches within the downtown district are found on the spacious homes along "Doctor's Row" on Main Street. Existing historic porches should be retained and carefully repaired and the design of replacement porches should be based upon solid physical or documentary evidence.

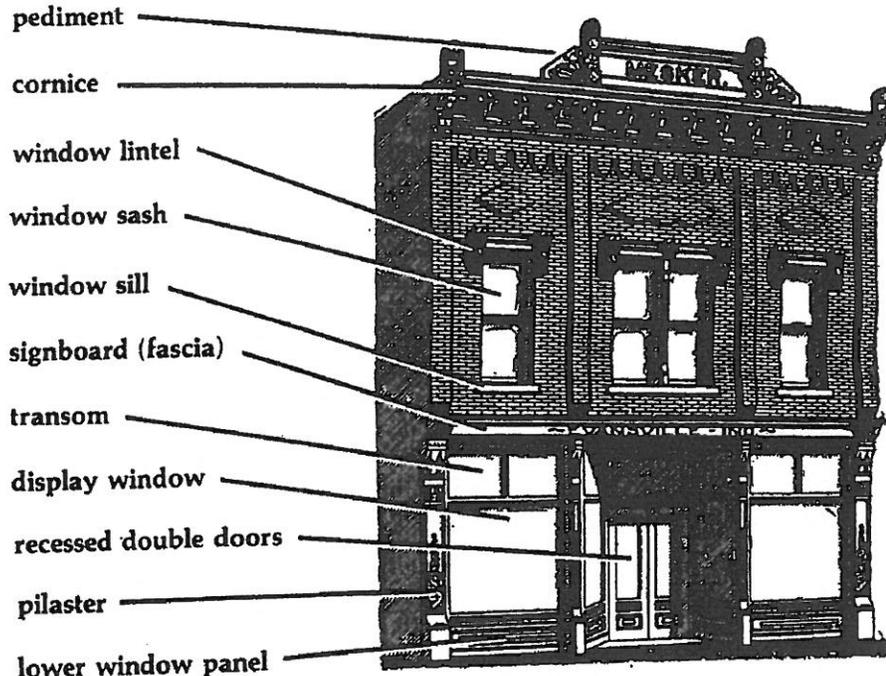
Fig. 18 This commercial facade was featured in the 1905 sales catalog of Mesker Brothers, a leading manufacturer and distributor of storefronts and ornamental metal trim. It is characteristic of most of the historic facades in downtown Peekskill. [reprinted and titles added in Preservation Brief No. 11, *Rehabilitating Historic Storefronts*]

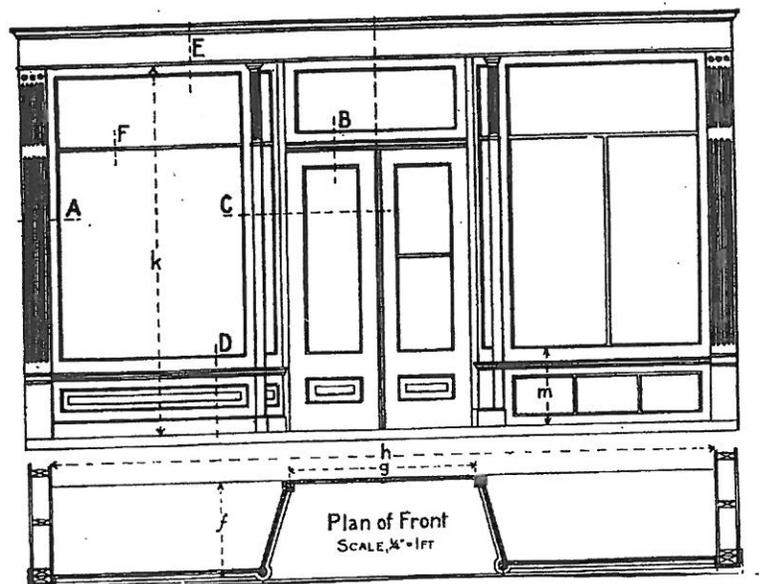
Fig. 19 This storefront drawing appeared in elevation and plan in the 1903 edition of the *General Catalog of E. L. Roberts*, Chicago-based millwork specialists. It shows the transparent qualities of the early twentieth-century storefront, the recessed entrance, bulkheads, transoms, etc., which should be retained in Peekskill's commercial buildings or should be designed in the course of storefront reconstruction projects.

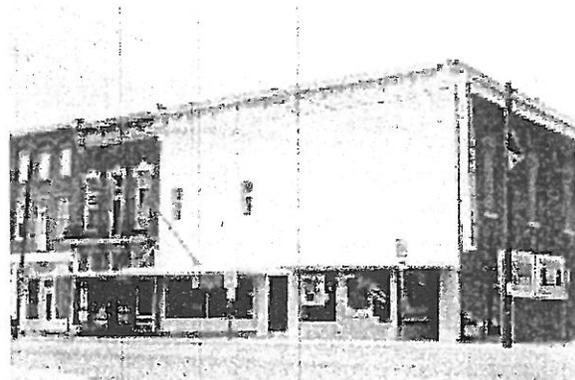
Fig. 20 The above photo illustrates the practice of “slipcovering,” involving the cladding of the upper facade on commercial buildings in non-historic materials. Such treatment is not appropriate for the Peekskill Historic District.

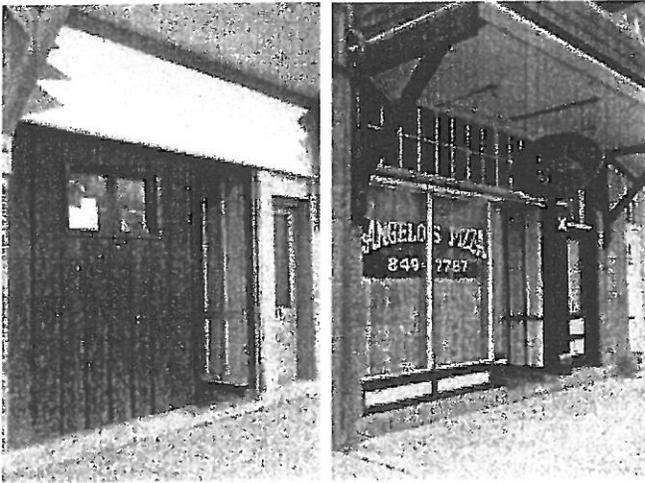
Fig. 22 The “before-and-after” views of this storefront rehabilitation project illustrate the design of compatible new bulkheads, the use of double-glazed display windows, the uncovering of previously-hidden transom windows, the use of color to accentuate architectural detail, and the highly effective use of both window and overhanging signage which is illuminated in an architecturally-compatible manner.

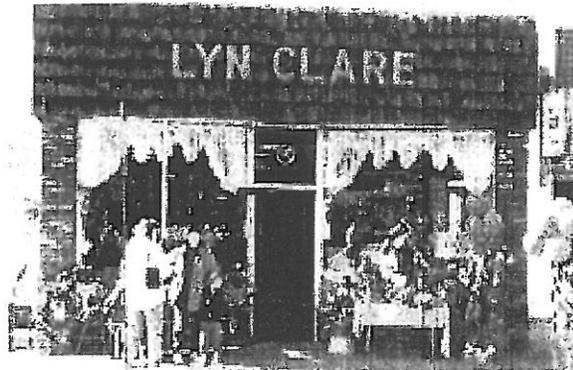
Fig. 23 Over the years, various renovation projects have resulted in the loss or obscuring of all historic materials on this nineteenth-century storefront. The latest application employed inappropriate treatments such as the use of artificial brick and a pent roof clad in wood shingles. Such rehabilitation treatments are not appropriate for the Downtown Peekskill Historic District.

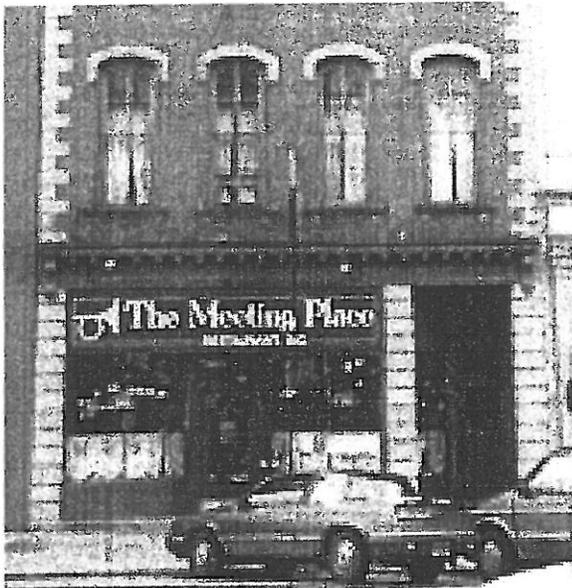
Fig. 24 The signage for this commercial building was carefully chosen and was executed in a manner consistent with the historic commercial character of the property, including the installation of a flat-mounted sign within the upright storefront piers and inside the signband designed for that particular storefront.

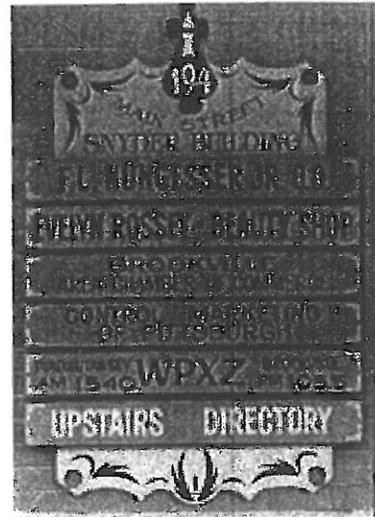
Fig. 25 This second-story directory incorporates the names of the tenants onto plaques which can be changed as tenants change. Although not apparent in the photo, the directory is also painted in the same combination of colors as the building itself.

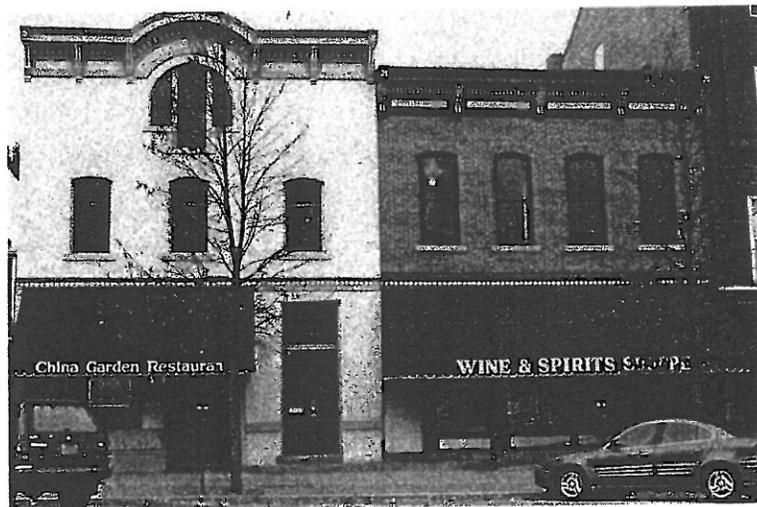
Fig. 26 These two buildings illustrate the use of stationary awnings whose location and graphics have been selected with great care. The use of such design solutions is encouraged for buildings throughout downtown Peekskill.

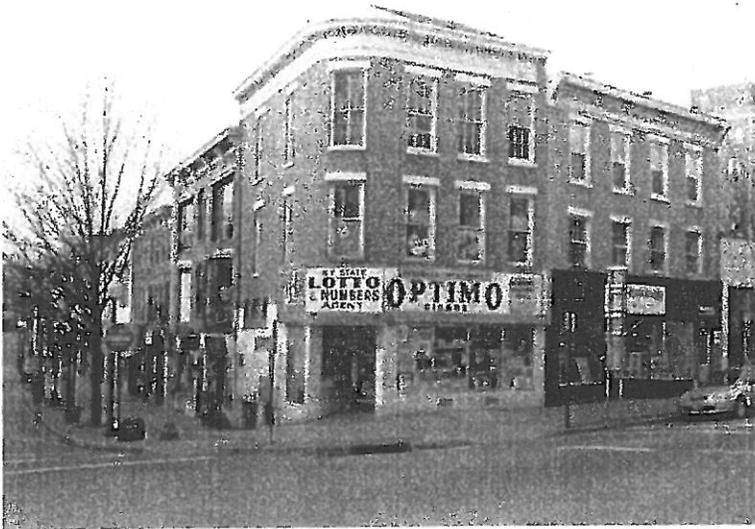
Fig. 27 The commercial character of much of the Downtown Peekskill Historic District incorporates a diversity of design dating from the era of the Civil War through the post-World War Two years. Property owners and tenants should always assure that their construction projects will not cause irreparable damage to the historic fabric of the district.

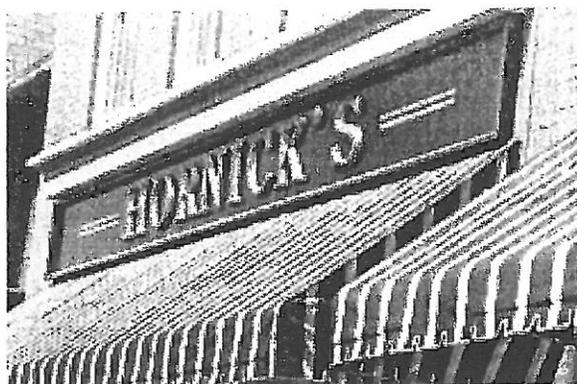
Fig. 28 Only in selected instances is the use of synthetic materials appropriate within the historic district. One such example is depicted above in the synthetic awning fabric and the plastic letters which were employed in this very successful storefront rehabilitation project.

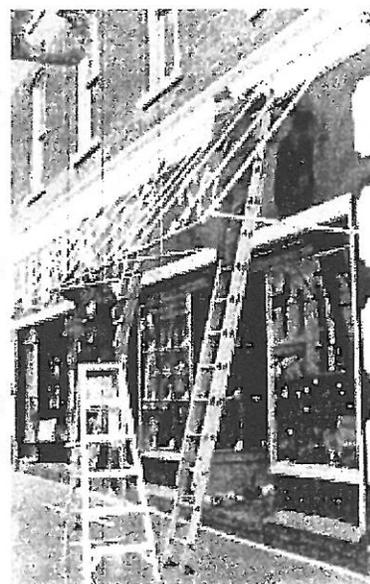
Fig. 29 The awning being installed here incorporates a system including a rigid pipe frame and a synthetic awning fabric. It is designed to remain extended throughout the year and employs a profile sufficiently sloped to assure that snow will not cause the structure to fail.

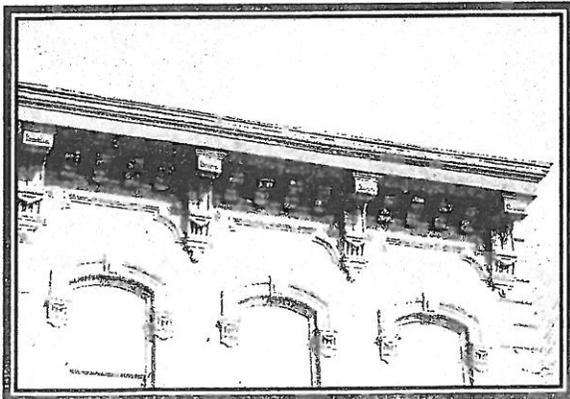
Overhanging bracketed cornices, tall and narrow window proportions, and heavy window heads are among the defining features of the Italianate style.

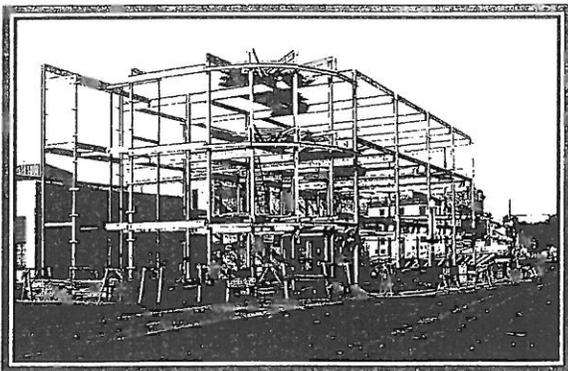
This construction photo shows the steel frame of the 1947 Moderne-style Genung Department Store at the corner of Main and Division Streets.
