# A STUDY OF THE STEPS REQUIRED TO PROVIDE FOR CURRENT AND FUTURE NEEDS OF THE PEEKSKILL FIRE DEPARTMENT BY RENOVATING AND ADDING ONTO THE CURRENT FACILITIES

**A Study of the Steps Required  
to Provide for Current and Future Needs  
of the Peekskill Fire Department  
by Renovating and Adding onto the Current Facilities**

**March 23, 2010**

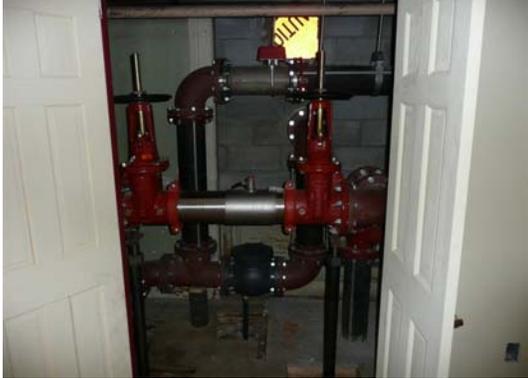
A photograph of a sprinkler riser. The riser is a vertical pipe with several horizontal pipes branching off. There are red valves and fittings. The riser is located in a utility room, and there is no sprinkler system attached to it.

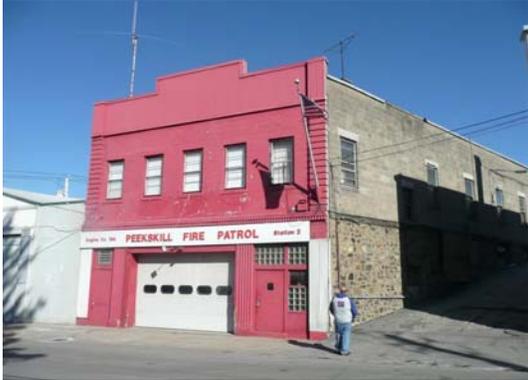
<ul style="list-style-type: none"><li>• No front apron; trucks must block street when returning</li><li>• No parking</li></ul>

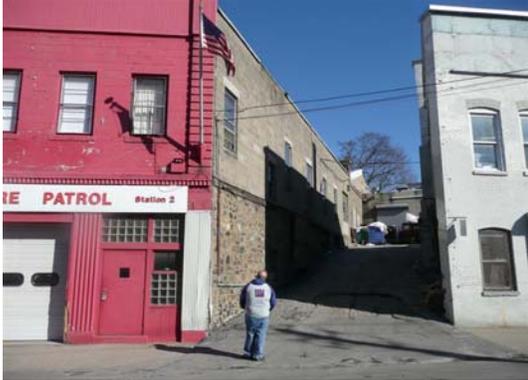
<ul style="list-style-type: none"><li>• Building occupies entire parcel</li><li>• No outdoor storage</li></ul>

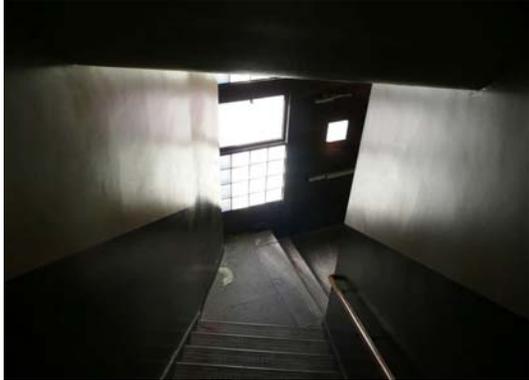
<ul style="list-style-type: none"><li>• Stair from 2nd floor does not meet ANSI requirements</li></ul>

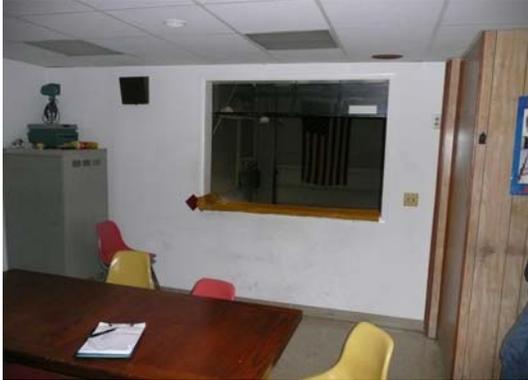
<ul style="list-style-type: none"><li>• Unprotected opening from kitchen/dining to apparatus bay</li></ul>

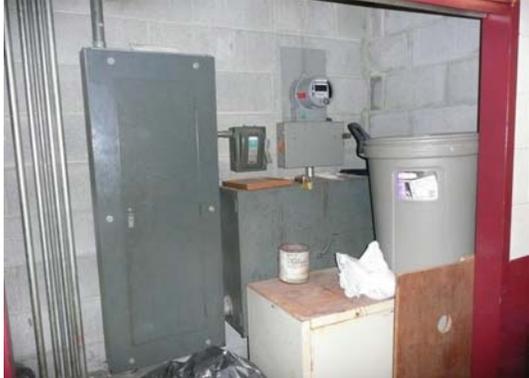
A photograph showing a stainless steel kitchen sink with a three-compartment basin. The area underneath the sink is cluttered with various items, including plastic bottles, a bucket, and other miscellaneous objects, illustrating inadequate storage.
<ul style="list-style-type: none"><li>• Inadequate storage area results in code violation</li></ul>

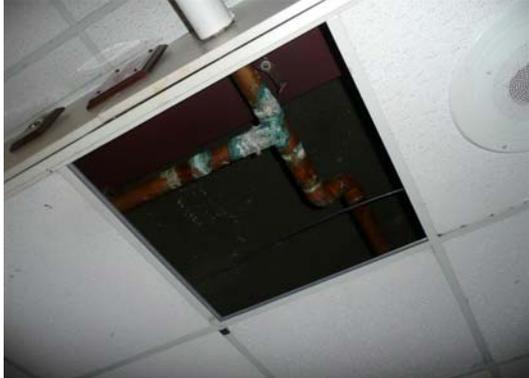
A photograph of a storage area. It features a large, grey metal cabinet on the left, a small table with a wooden top in the center, and a large grey trash can on the right. The area appears cluttered and disorganized.
<ul style="list-style-type: none"><li>• Corrosion from leaking plumbing</li></ul>

A photograph looking up at a ceiling. A large section of the ceiling is missing, revealing a network of pipes and plumbing fixtures. The pipes appear to be in poor condition, with some showing signs of rust or corrosion.

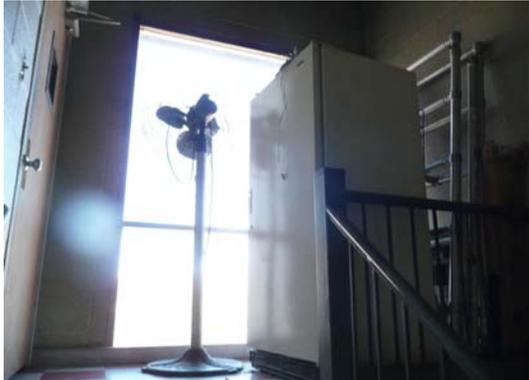
A photograph showing a close-up of mechanical equipment, including a white air conditioning unit and various pipes and wires, installed in a room with bunk beds.
<ul style="list-style-type: none"><li>• Inadequate storage area results in code violation of storage on stairwell landing</li></ul>

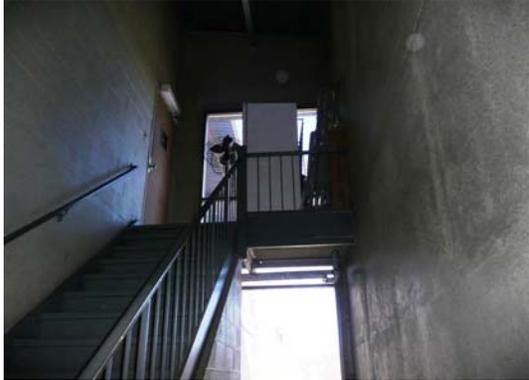
A photograph of a stairwell landing area. A large floor fan is positioned in the center, and a white cabinet or storage unit is visible on the right side. A window is on the left, and a staircase with a metal railing is on the right.
<ul style="list-style-type: none"><li>• Stair does not comply with ANSI standards</li></ul>

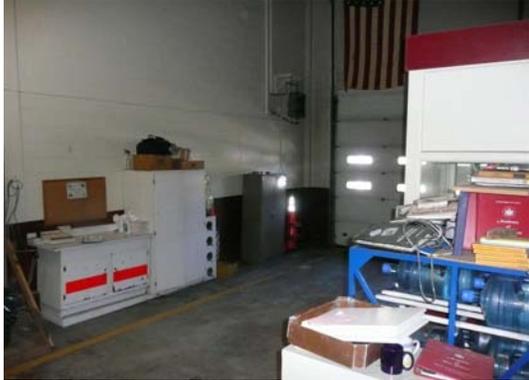
A photograph of a narrow stairwell. The stairs are dark, and the walls are light-colored. A metal railing is visible on the left side. The space appears cramped and narrow.
<ul style="list-style-type: none"><li>• Inadequate storage area results in congested apparatus bay</li></ul>

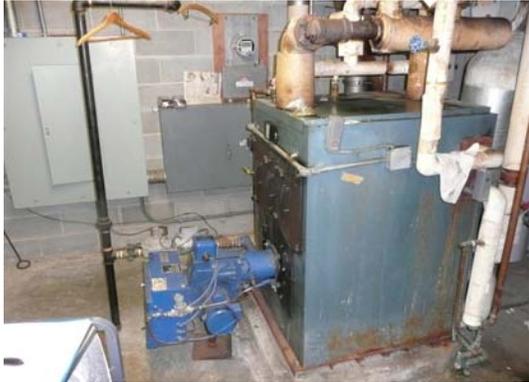
A photograph of a mechanical room. On the left, a computer monitor sits on a metal stand. In the center, a blue metal cabinet is partially covered with a white cloth. To the right, a blue water cooler is visible. The room contains various pipes and electrical conduits.
<ul style="list-style-type: none"><li>• Lack of storage results in code violation of storage in mechanical room</li></ul>
